PUBLIC WORKS DEPARTMENT

# DOWNTOWN PARKING STRUCTURE CONDITION ASSESSMENT

Lots 2, 6, 7, 10, 11, and Depot Lot Structures

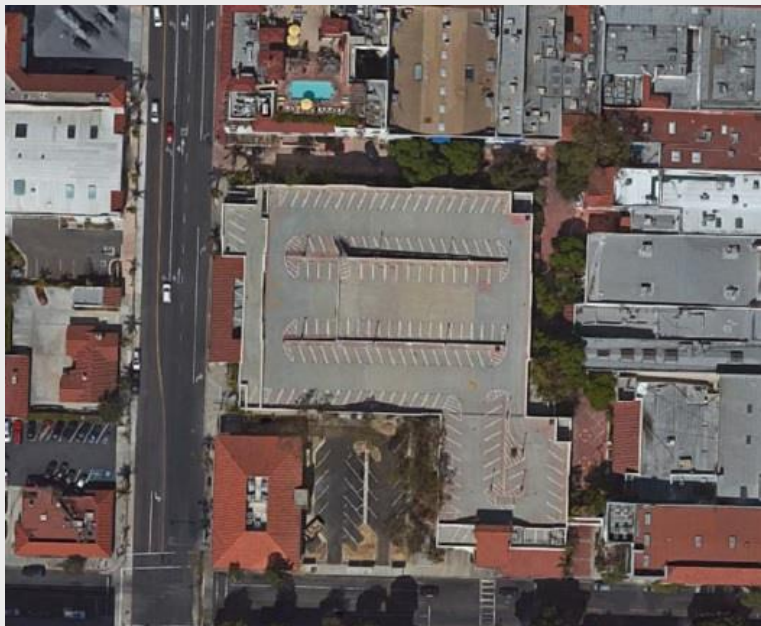
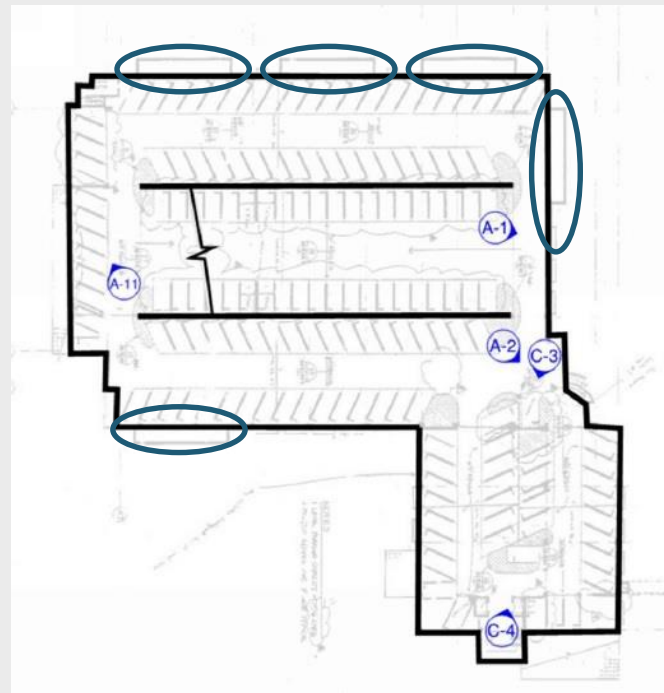
## Lot 2, 10 – Barrier Rails

- Existing balcony rails are not vehicle rated
- Balcony rails do not meet pedestrian guardrail requirements
- Crash tested barrier rails recommended

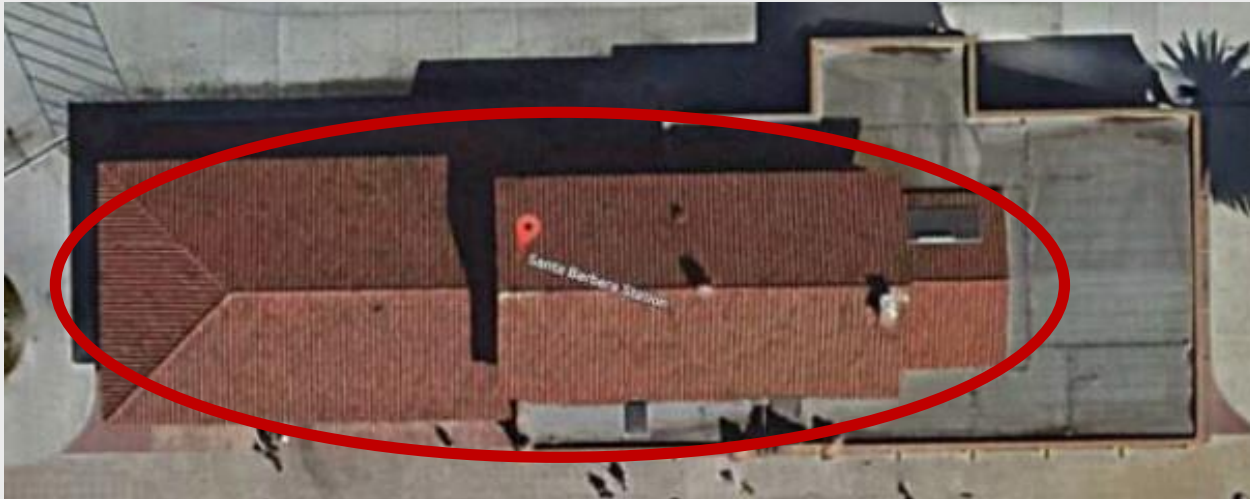
# Amtrak Building – Clay Tile Roof

- Clay Tile Roofs generally in good condition
